ADDITIONAL OFF-HIRE INSPECTION QUESTIONS

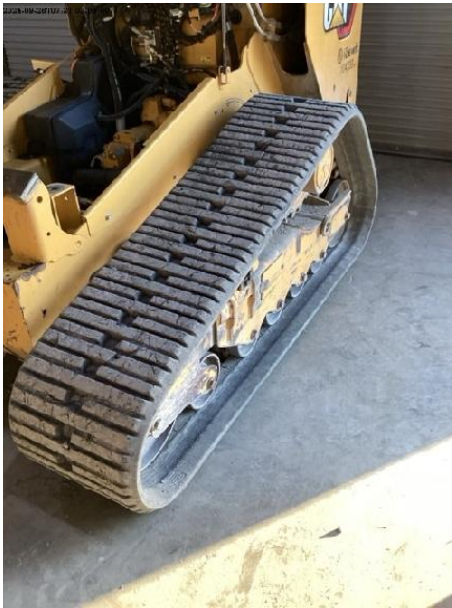
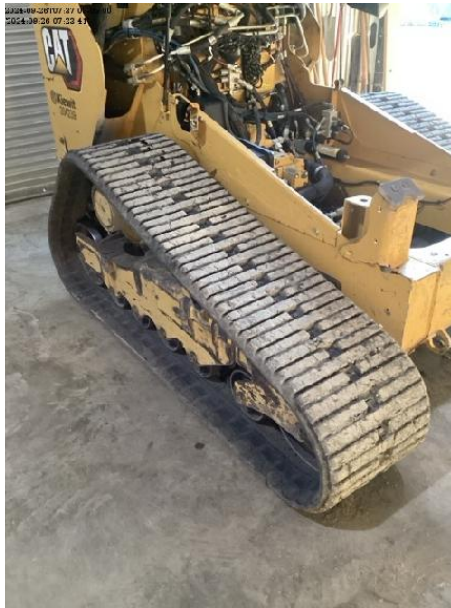
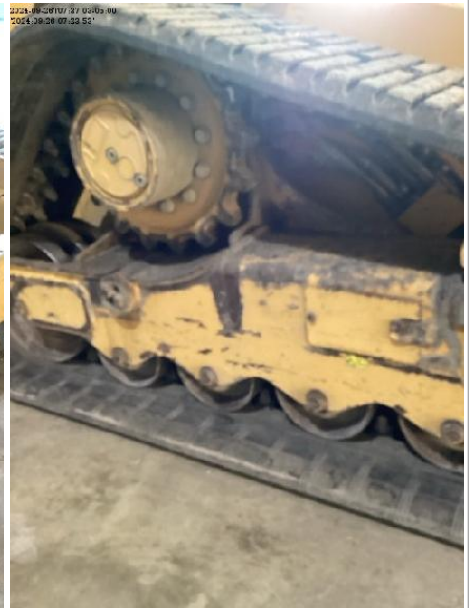
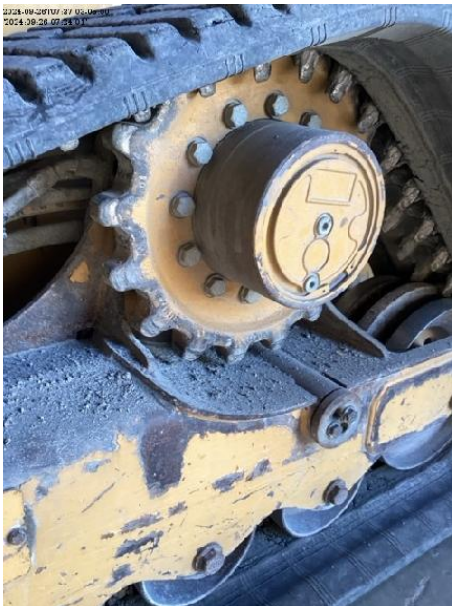
OVERALL CONDITION

NORMAL

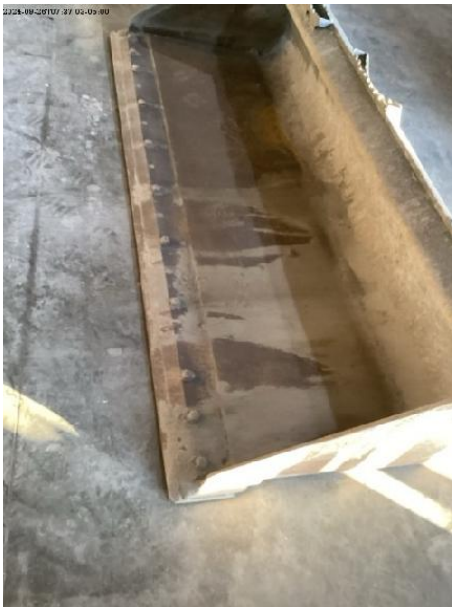
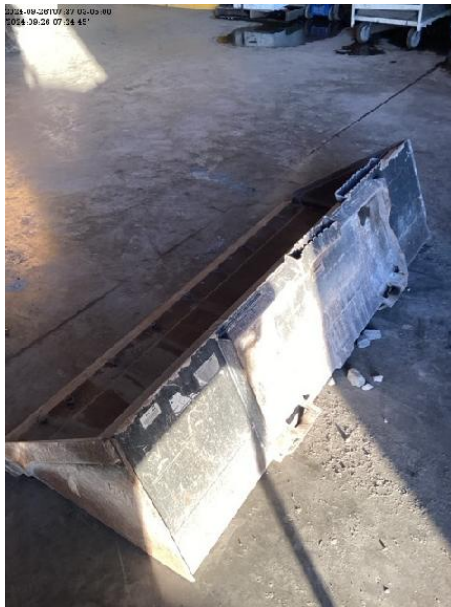
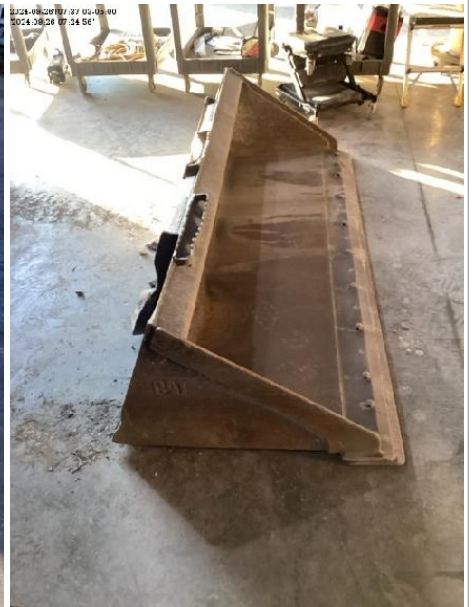
BUCKET

NORMAL

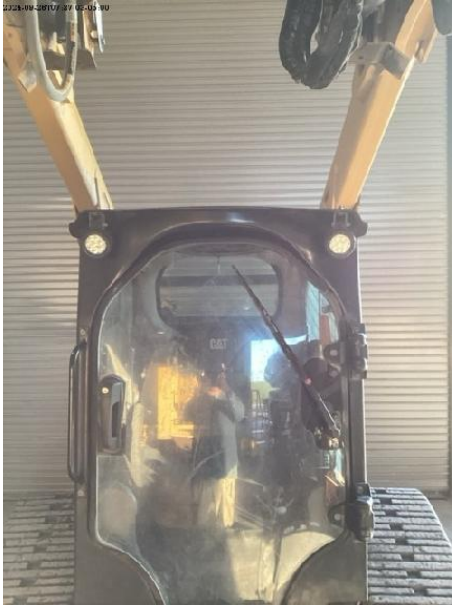
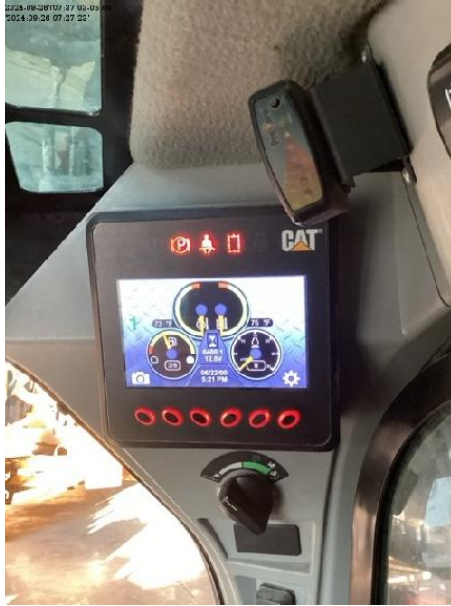
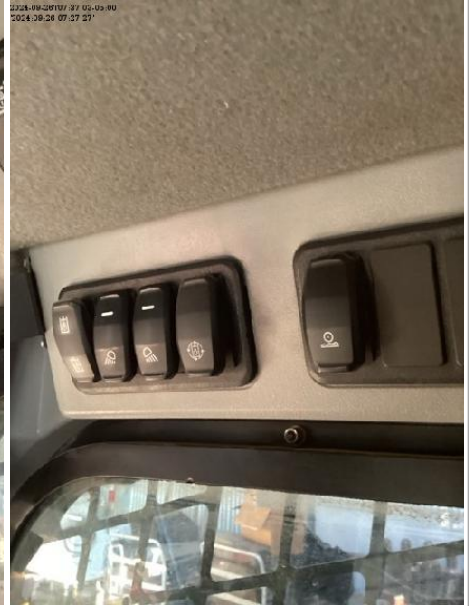
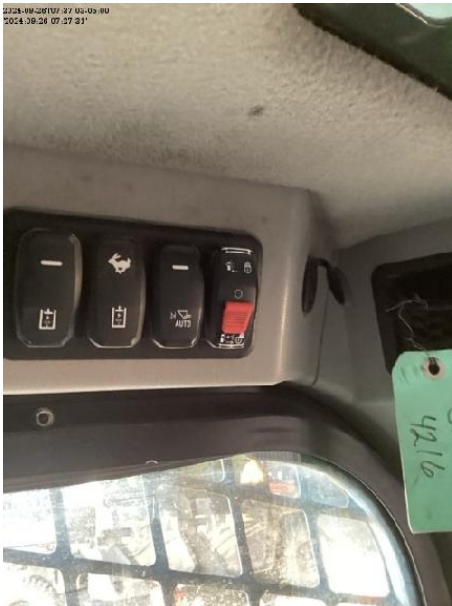
OVERALL CONDITION

NORMAL

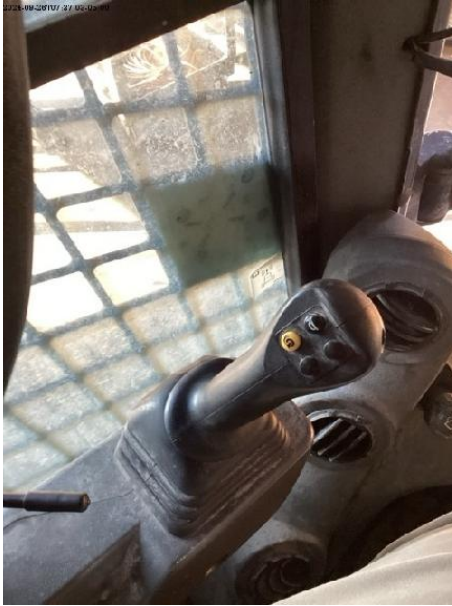
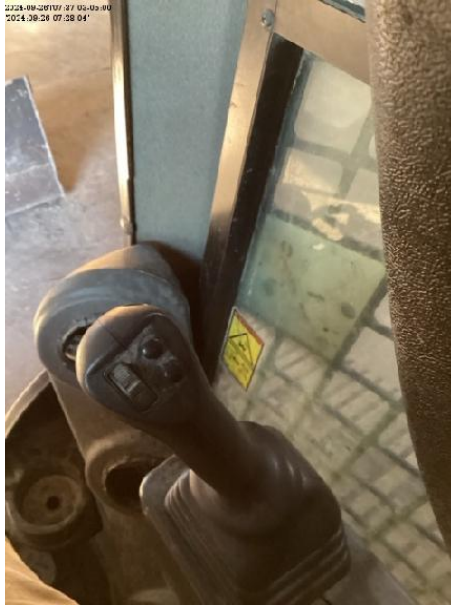
CAB CLEANLINESS
OVERALL CONDITION

NORMAL
NORMAL

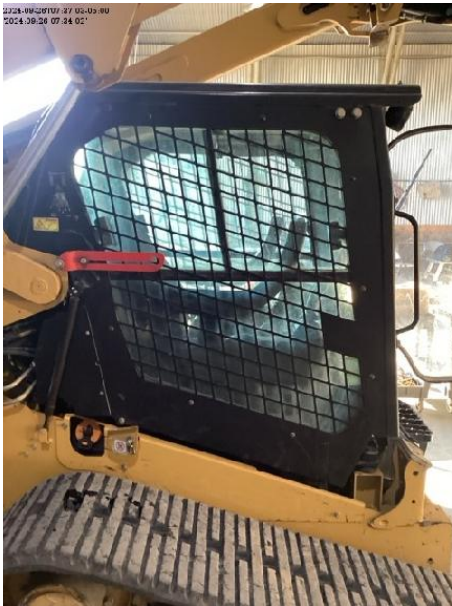
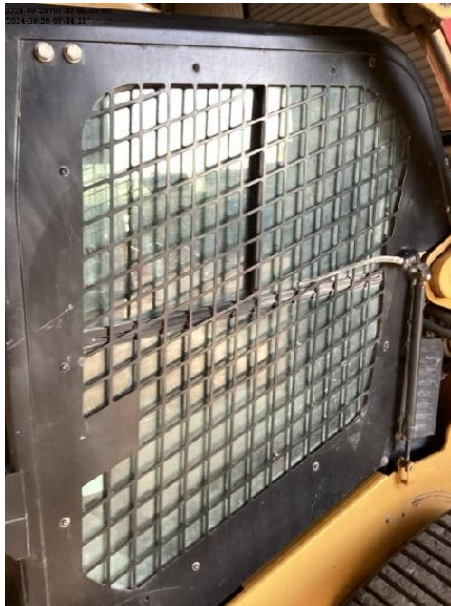
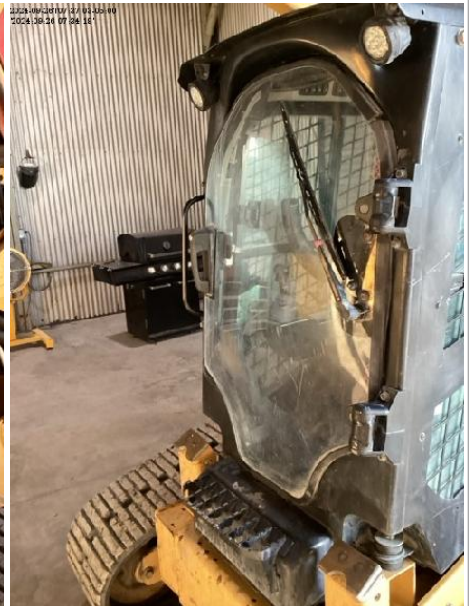
WINDOWS/MIRRORS OVERALL CONDITION

NORMAL
